# The « Grand Palais des Beaux-arts » of PARIS

Protection against lightning of a historical monument.

**Abstract** — The « Grand Palais des Beaux-arts », a historical monument, changes one's image.

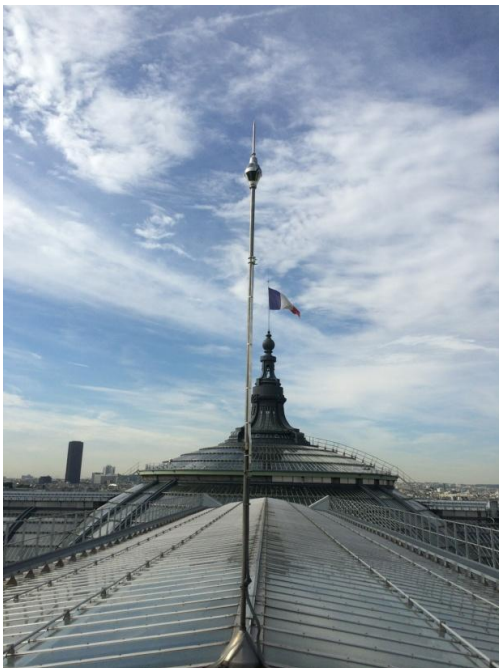
We have replaced, 3 ESE in stainless steel material (advance time :  $\Delta T = 60$  microseconds) remoted, "Satelit 3-60™", brand "Duval-Messien", mounted on stainless steel masts and installed to extend at least 2 meters more than the highest point of the building.

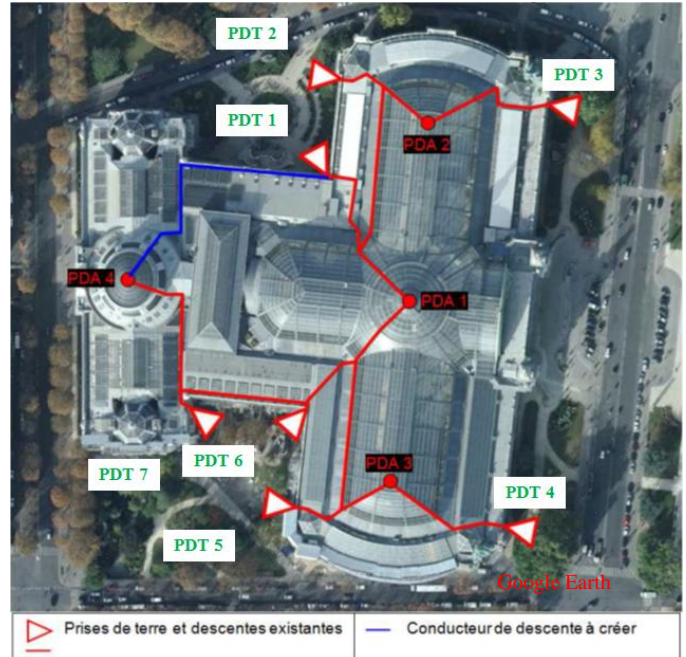
From the Early Streamer Emission (PDA 4), to the nearest down conductor (connected to the grounding earthing system nbr.1), we have installed a new external down conductor on the roof of the building, in copper material, 30x2 mm.

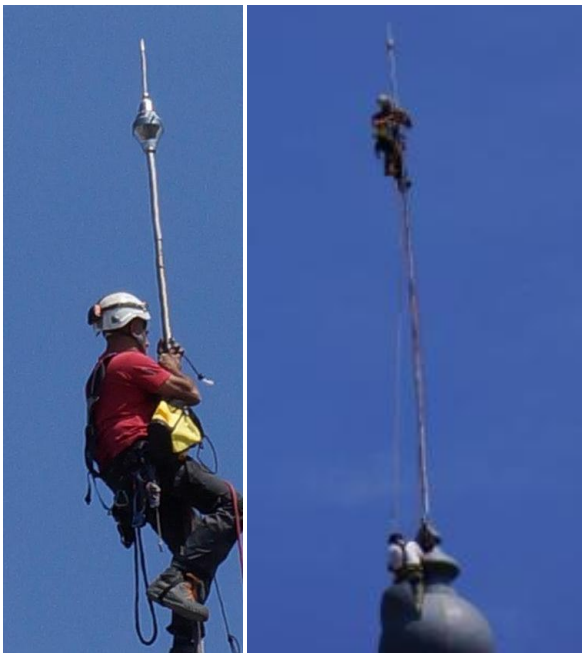
In agreement with the management of the building and technical resources, because of the lack secure access to replace the ESE (fragile glass), the work could not be realized with the rope. Due to the configuration of the place, the implementation of a nacelle on truck was not a solution (even with a machine with a large working height). This work will be done out during the repair of the glass canopy to be held current 2016.
