# The « Grand Palais des Beaux-arts » of PARIS

Protection against lightning of a historical monument.

**Abstract** — The « Grand Palais des Beaux-arts », a historical monument, changes one's image.

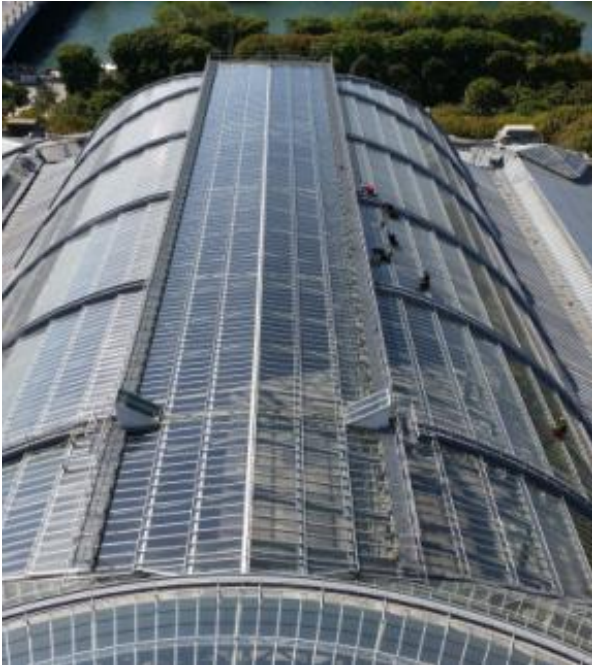
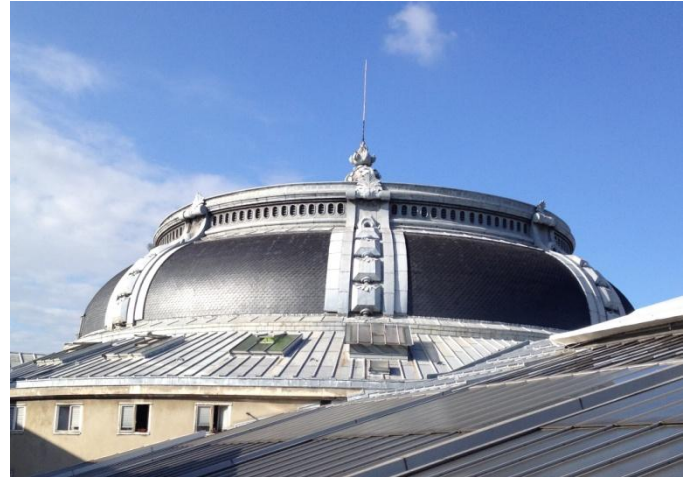
This monument is largely made of glass, it was necessary to take extreme caution to go up to the roof to avoid damaging it.
