## ANGKOR VAT TEMPLE LIGHTNING PROTECTION

Sylvain Fauveaux      Arnaud Lefort  
INDELEC (France)

**Abstract – The Temple of Angkor Vat is one of our precious Architectural and Cultural World Heritage. Being located in the Kingdom of Cambodia, this 12<sup>th</sup> century architectural complex suffered from lightning aggression. Shortly after the end of the local conflict, it was decided to protect this 8<sup>th</sup> Wonder of the World candidate. This challenging task had to cope with architectural and UNESCO constraints. A risk assessment being realized, an ESE lightning protection was proposed and installed in a proper way to avoid alterations of this stone made National Monument. A discussion about recent risk assessment method applied to this particular building is held.**

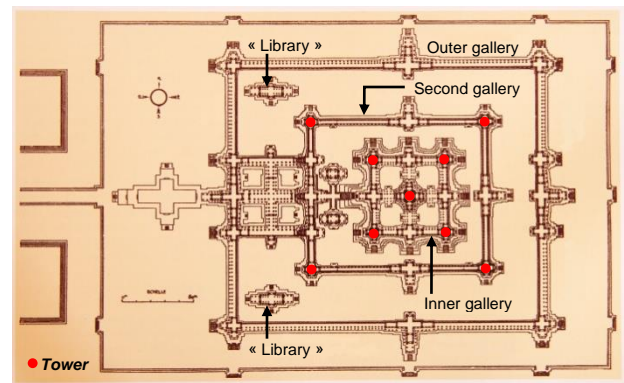
Figure 3 - Blueprint of Angkor Vat (scale is 50m)

The temple stands on a terrace raised above the level of the city. It consists essentially of three rectangular galleries rising to a central tower; with each level higher than the last one (figure 3).

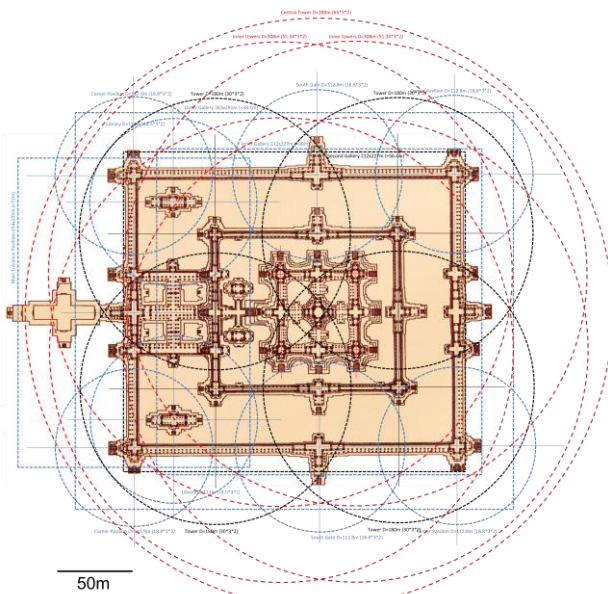
Figure 8 – Collection Area for Flashes of the Temple

Whatever Lightning Risk Analysis used, the equivalent collection area for flashes must be calculated. It is a function of the size and height of the building. As the complex is large and tall with many different heights, the determination of the equivalent area is not direct. The calculation is based upon graphical method owing to *Table I*.

The collection area of the whole temple (delimited by the 3 galleries) is by far dominated by the central tower (*figure 8*). It was calculated according to lightning standards [6;7;8]. The total area is equal to about 123,517m<sup>2</sup> (0.123km<sup>2</sup>).

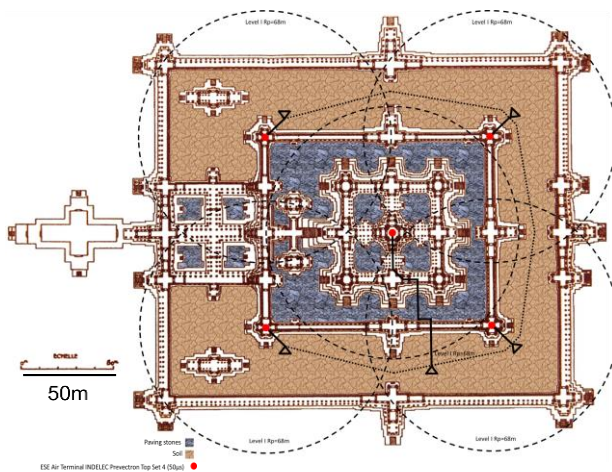
Figure 9 – ELPS of the temple and zone of protection

The ground of the area between by the inner wall and the second gallery is soil. The ground of the area inside the second and inner galleries is made of stone pavement as colorized in figure 2 and figure 9.

In order to protect any towers and cover the area of the temple, 5 Early Streamer Emission Air Terminals (ESEAT) were implemented (*figure 9*) at the top of 2 meter poles to limit the visual annoyance. These 5 ESEATs were manufactured and supplied by the INDELEC Company, Top Set 4 model, 50µs advance time each. This model was preferred because of its low profile and unobtrusive silhouette. Its protection radius is 68m at Level of Protection I according to the standard [6]. The protection zone perfectly covers any tower, as specified by the technical requirement specifications, as
